AIRCRAFT ACCIDENT REPORT

SOUTHERN AIRWAYS, INC. DC-9, N97S

Tri-State Airport

November 14, 1970

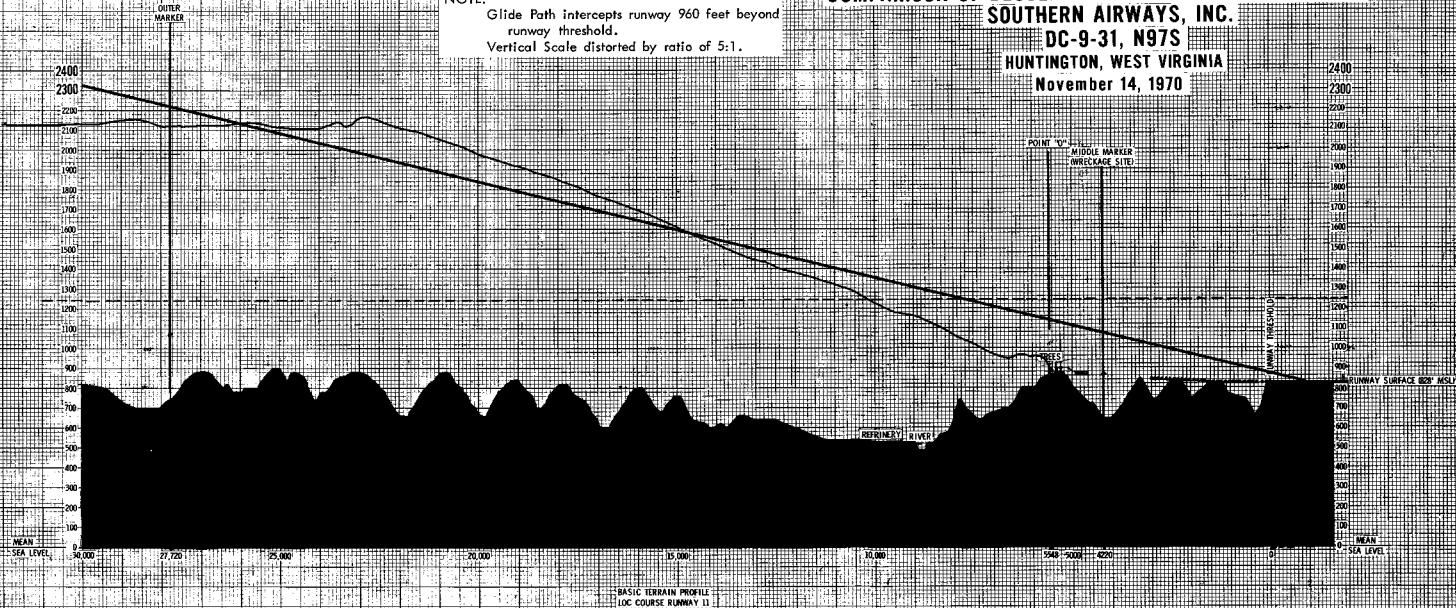
BASIC TERRAIN PROFILE
LOC COURSE RUNWAY 11

--- MINIMUM DESCENT ALTITUDE
— 3° GLIDE PATH
— DESCENT PROFILE

NOTE:
Glide Path intercepts runway 960 feet beyond
runway threshold.
Vertical Scale distorted by ratio of 5:1.
